# Box Hill - South Tributary Restoration Monitoring Report

Prepared for:  
The Harford County  
Department of Public  
Works

January 2005

Prepared by:  
KCI Technologies Inc.  
10 North Park Drive  
Hunt Valley, MD  
21030

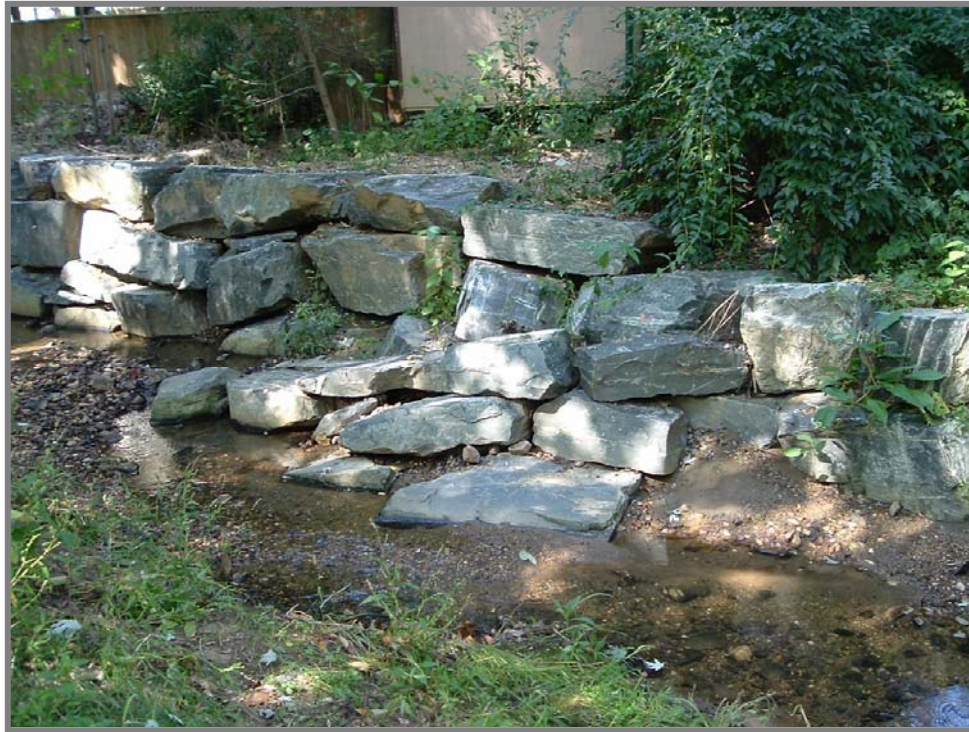
Photo ID 3 – Station 3+09 to 3+24, minor down-cutting of the channel bed, September 2004  
Note exposed footer rock

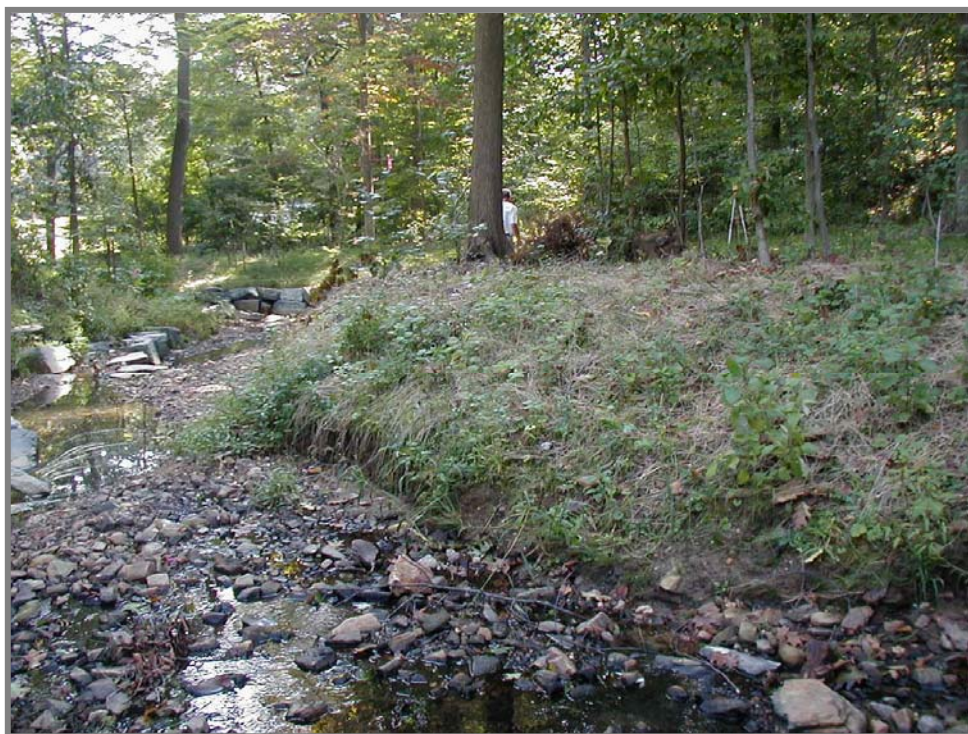
Photo ID 10 – Stations 5+50 to 6+25, facing downstream, September 2004  
Note erosion at toe of bank

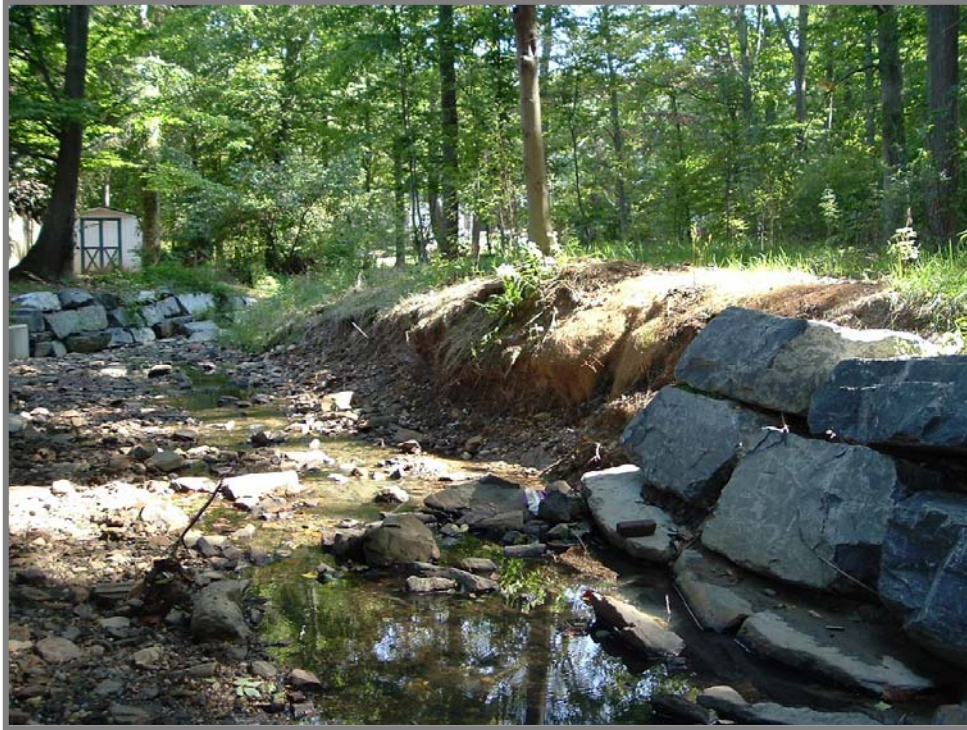
Photo ID 11 - Stations 5+50 to 6+25, facing downstream, September 2004  
Note erosion of bank

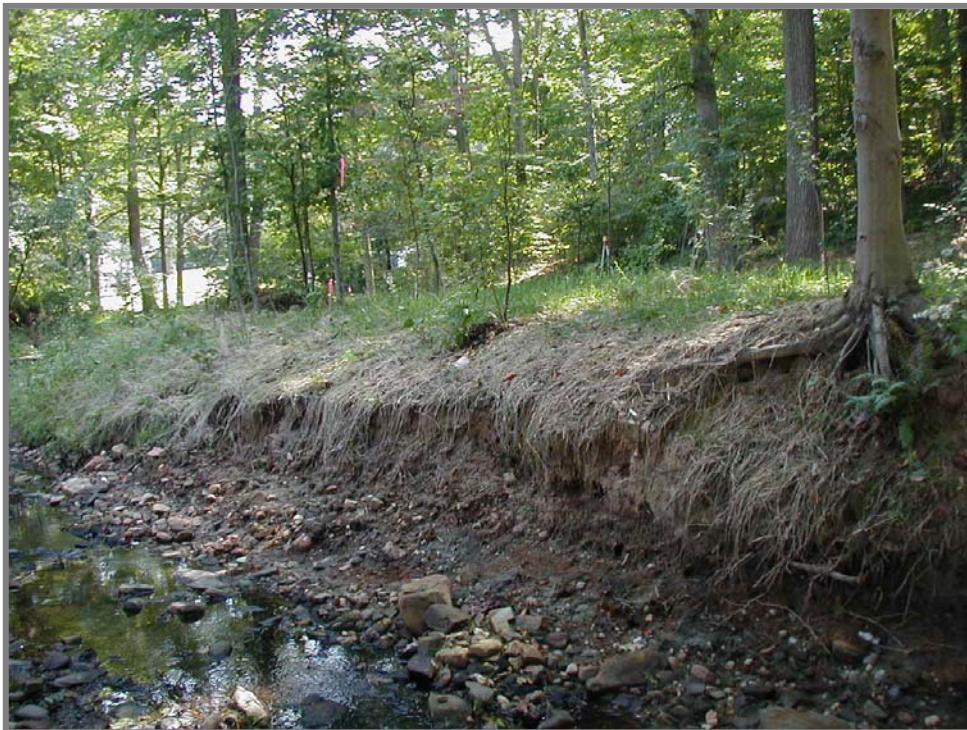
Photo ID 12 - Stations 5+50 to 6+25, facing downstream, September 2004  
Note erosion of bank

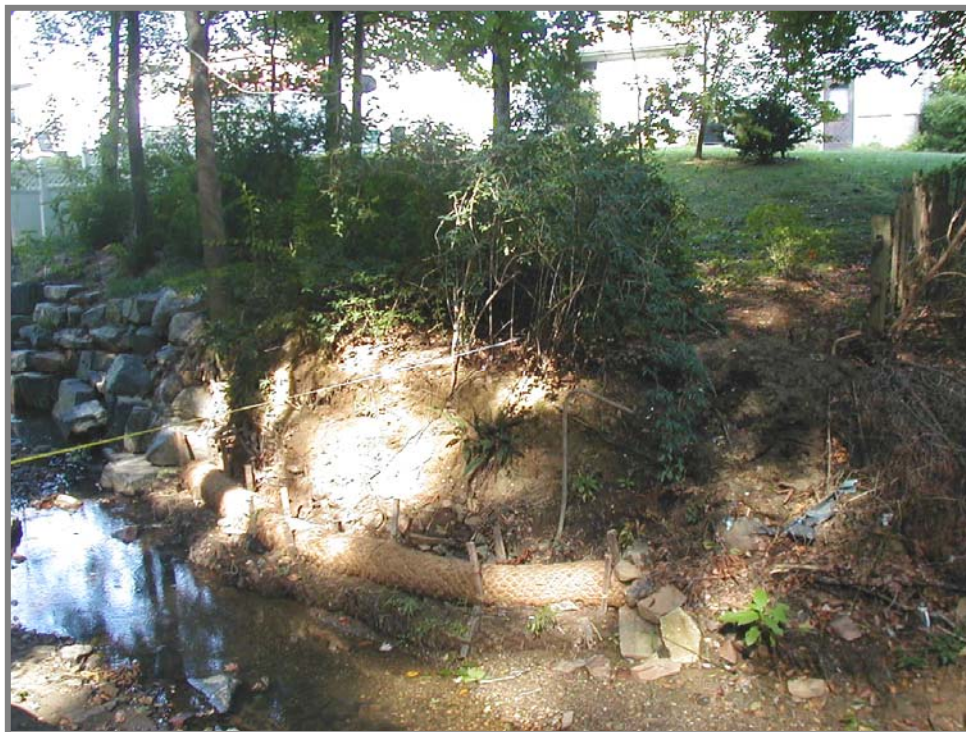
Photo ID 15 – Station 6+48, right bank, September 2004  
Note yard debris and bare bank

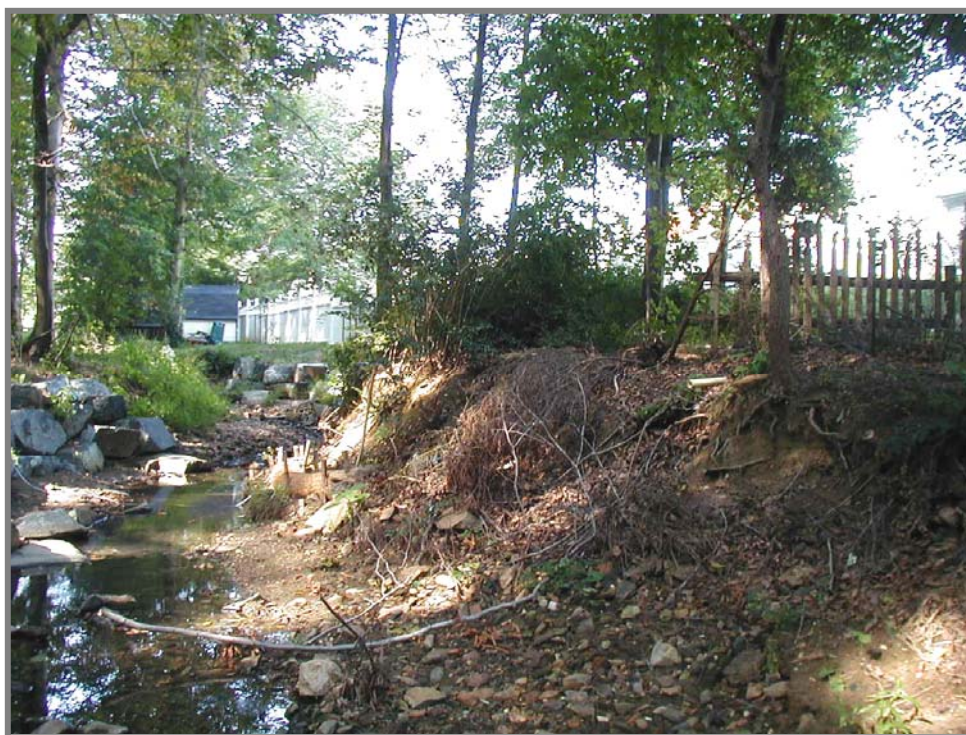
Photo ID 16 – Station 6+20 to 6+55, right bank facing upstream,  
September 2004  
Note exposed bank/roots drainage pipes

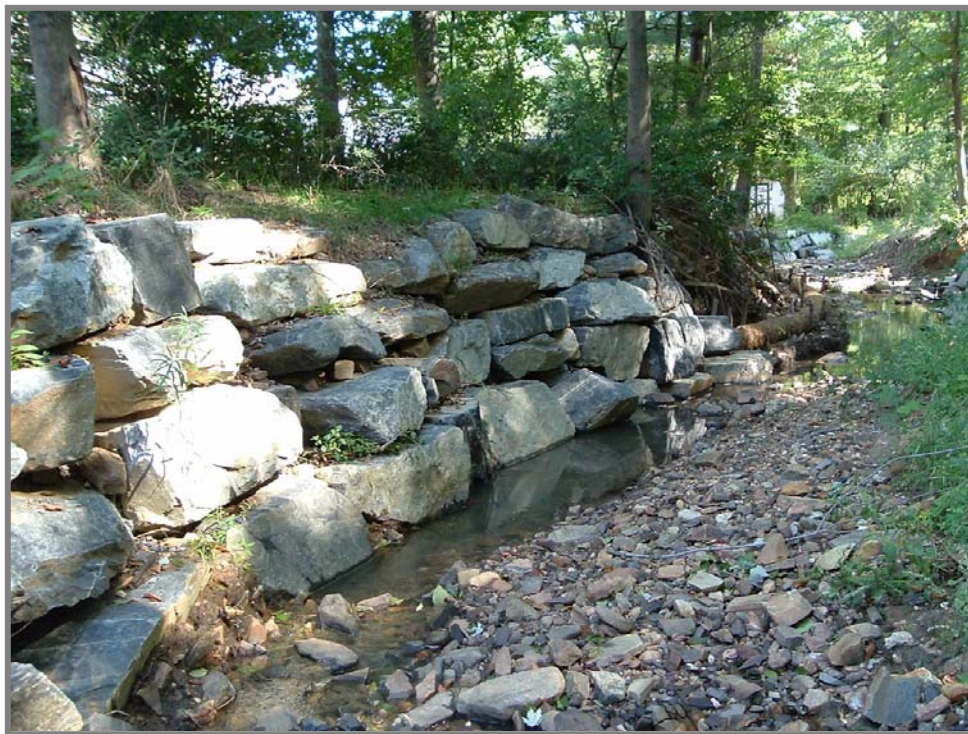
Photo ID 17 – Stations 6+70 to 7+10, minor down-cutting of the channel bed, facing downstream, September 2004

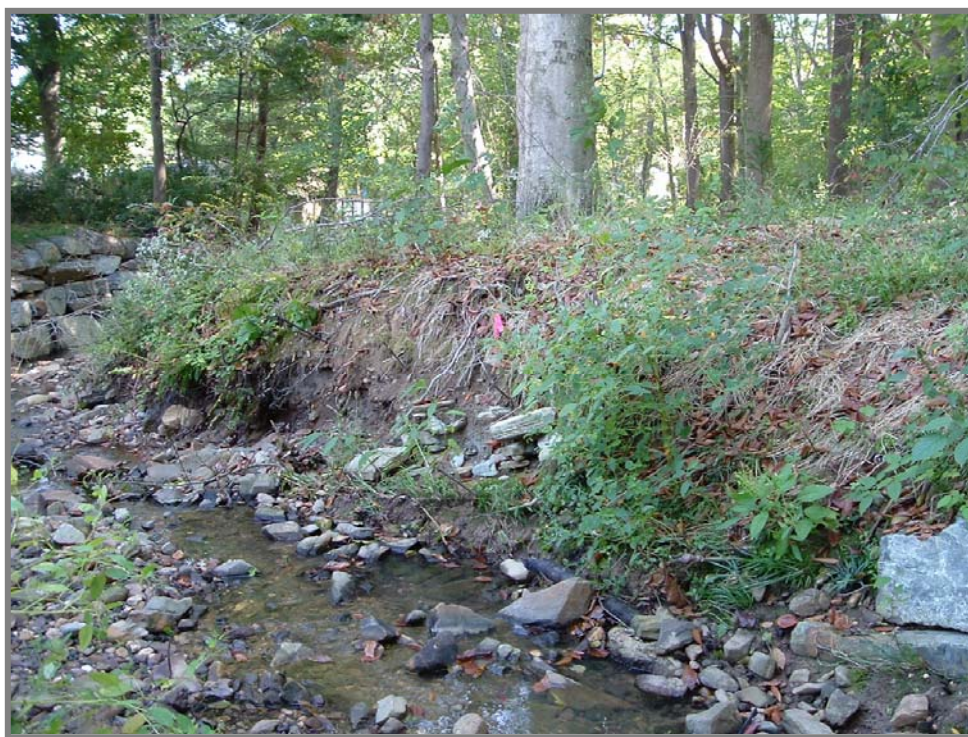
Photo ID 18 – Stations 7+14 to 7+39, facing downstream, September 2004  
Note exposed bank/roots

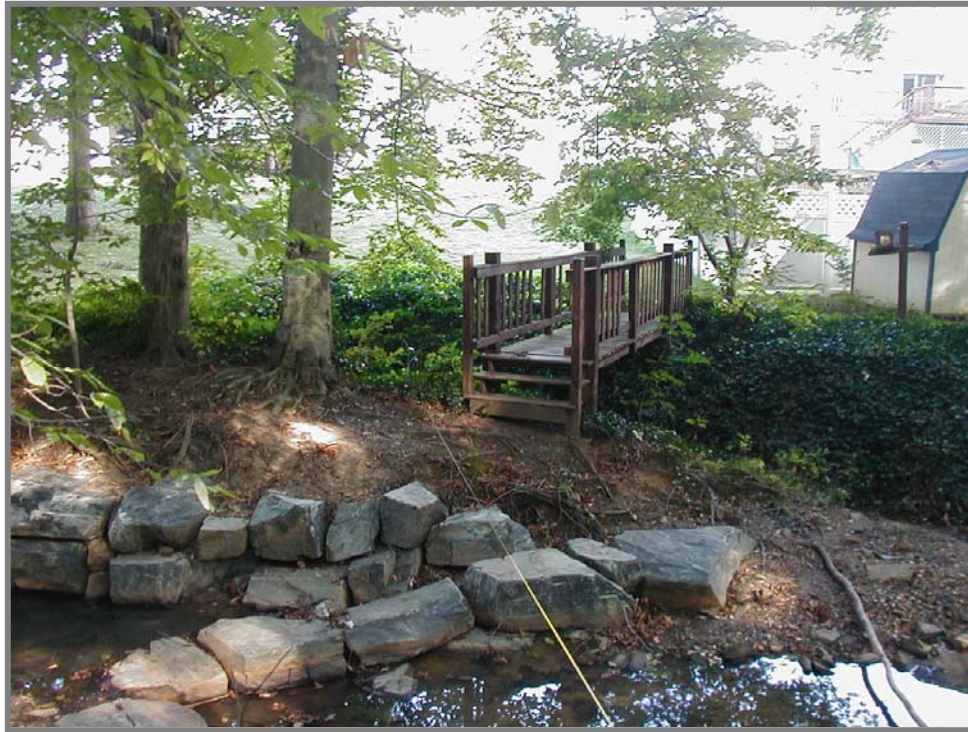
Photo ID 21 – Station 7+92, right bank, September 2004  
Note exposed right bank/minimal vegetation

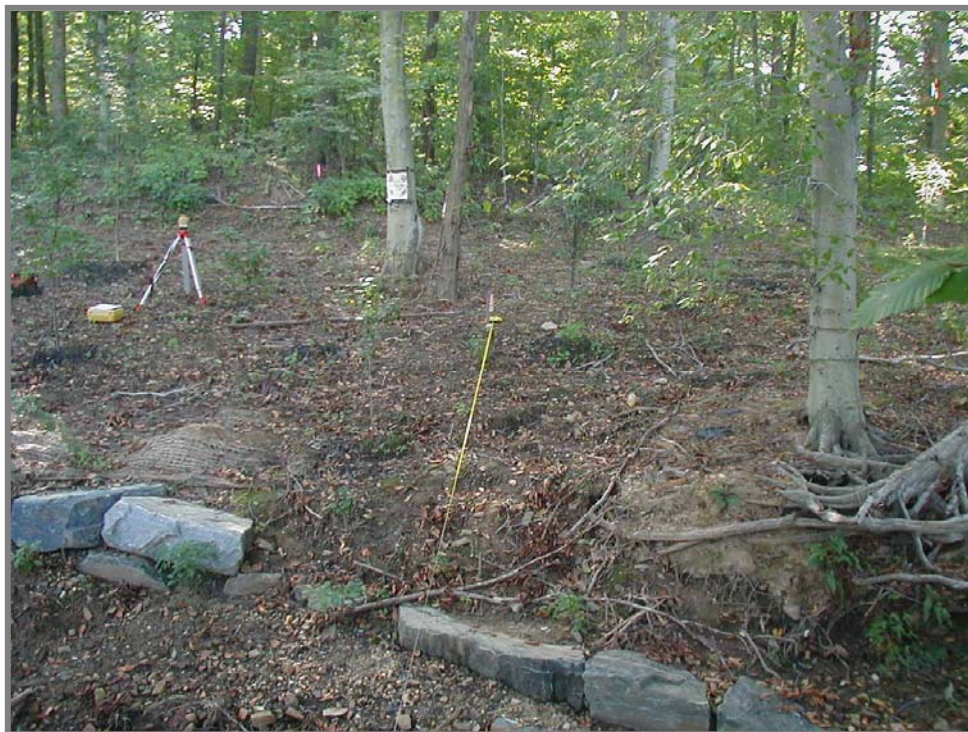
Photo ID 22 - Station 7+92, left bank, September 2004  
Note exposed left bank/minimal vegetation
